- FORD:** 1992-1997 THUNDERBIRD
1992-2003 CROWN VICTORIA, ESCORT, TAURUS
1995-2000 CONTOUR
1996-2003 MUSTANG
2000-2003 FOCUS
2002-2003 THUNDERBIRD
1997-2003 E SERIES, EXPEDITION, EXPLORER, F-150, WINDSTAR
1999-2003 SUPER DUTY F SERIES
2000-2003 EXCURSION
2001-2003 ESCAPE, EXPLORER SPORT TRAC, EXPLORER SPORT, RANGER
- LINCOLN:** 1992-2003 TOWN CAR
1993-1998 MARK VIII
1995-2002 CONTINENTAL
2000-2003 LS
1998-2003 NAVIGATOR
2002 BLACKWOOD
2003 AVIATOR
- MERCURY:** 1992-1997 COUGAR
1992-2003 GRAND MARQUIS, SABLE
1995-2000 MYSTIQUE
1997-1999 TRACER
1999-2002 COUGAR, COUGAR
1993-2002 VILLAGER
1997-2003 MOUNTAINEER

Article **02-20-2** is being republished in its entirety to update the measurements in the Service Procedure.

Article No. 02-21-13 Cont'd.

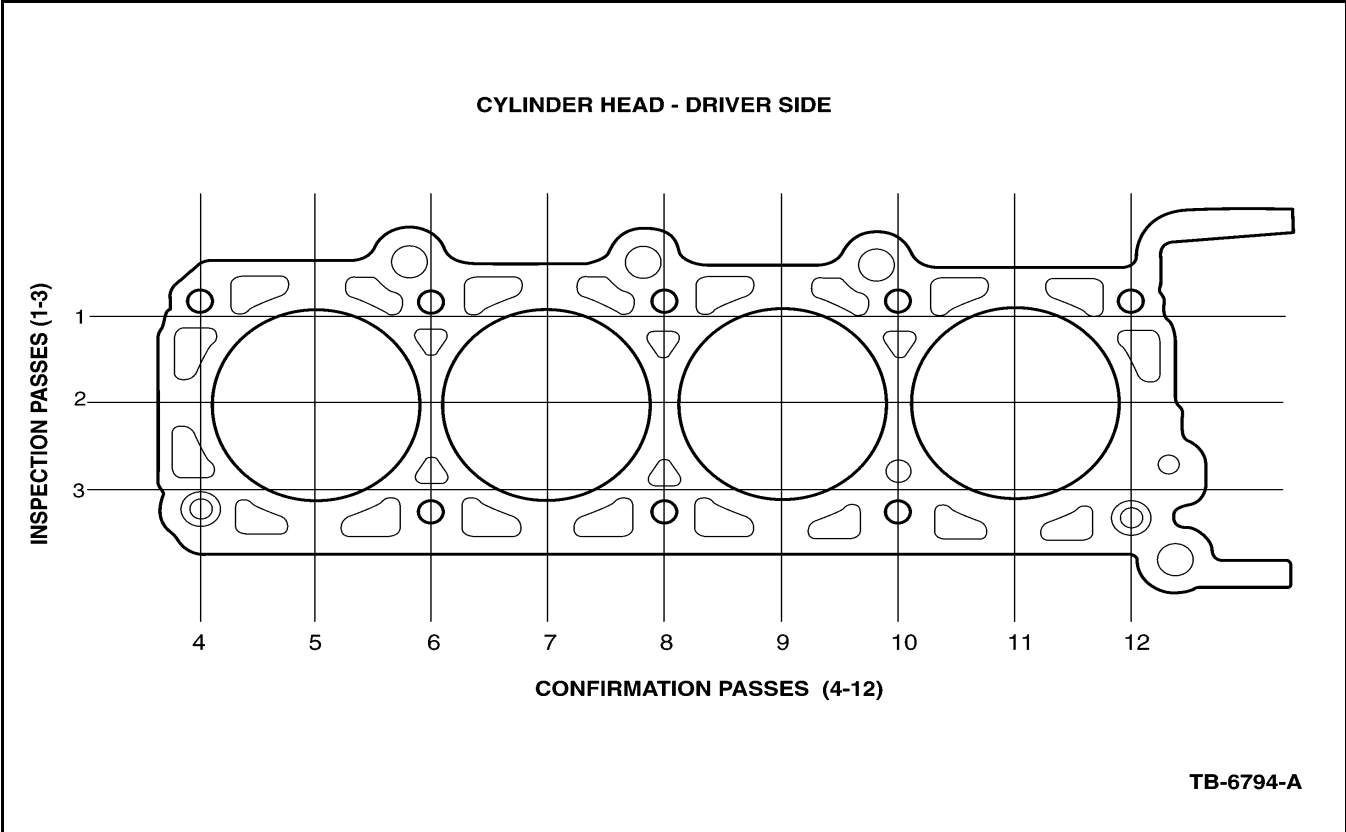
Figure 1 - Article 02-21-13

Figure 1 demonstrates a 12 point check system using a grid format on a 4 cylinder bank. It is important to note that a localized area of approximately 1.0 to 2.0 sq.in. will influence the effectiveness of the MLS gasket sealing capability. Depressions or marks measured to be over 0.001 inch deep will not seal properly. The overall flatness check (head end to other end) is not as critical.

As shown with Inspection Planes 1 through 3 (Figure 1), check these areas locally with the gauge looking for suspect depression areas of 0.001 inch or more. Then, check these same areas again, perpendicular, using Confirmation Planes 4-12. The second pass will confirm a suspect area because you are using a shorter span of the straightedge. The first pass (Planes 1-3) is necessary because the overall end to end flatness must be accounted for before doing the secondary passes, Planes 4-12.
