• **SUSPENSION—ON-VEHICLE FRONT INTEGRATED HUB/BEARING ROCKING END-PLAY MEASUREMENT**

**Article No.
03-11-2**

FORD: 1999-2004 SUPER DUTY F SERIES
2000-2004 EXCURSION

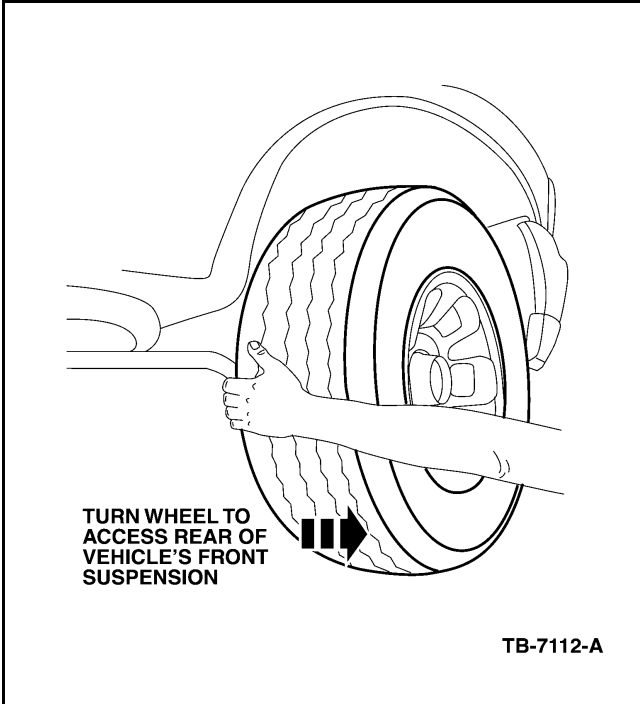
Figure 1 - Article 03-11-2

1. Make sure 4X4 hubs are unlocked.
2. Raise the vehicle until the front tires are off the ground.
3. Turn the wheel to allow for easier access to rear of vehicle's front suspension (Figure 1).

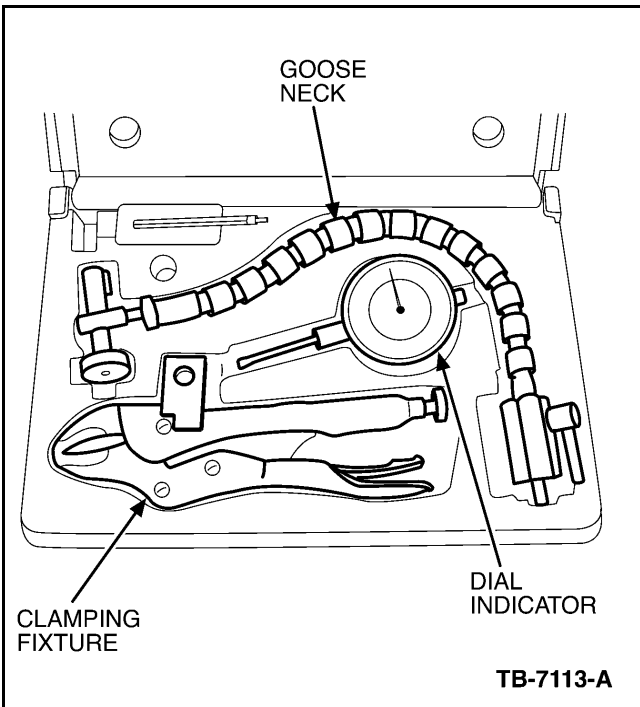
Figure 2 - Article 03-11-2

6. Fasten the dial indicator base (Figure 2), from Rotunda Kit 164-R2724 (or equivalent), to the knuckle as shown (Figure 3).
7. While adjusting goose neck, place probe of indicator on Rotor where splash shield has a V-type opening on inboard side of suspension assembly or about at the 5 O'clock position (Figure 4). Set the probe so that it is free to move in the lateral direction (Figure 5). With indicator and probe set in their mid-point range of operation, tighten the goose neck until it is rigid enough to assure accurate readings.

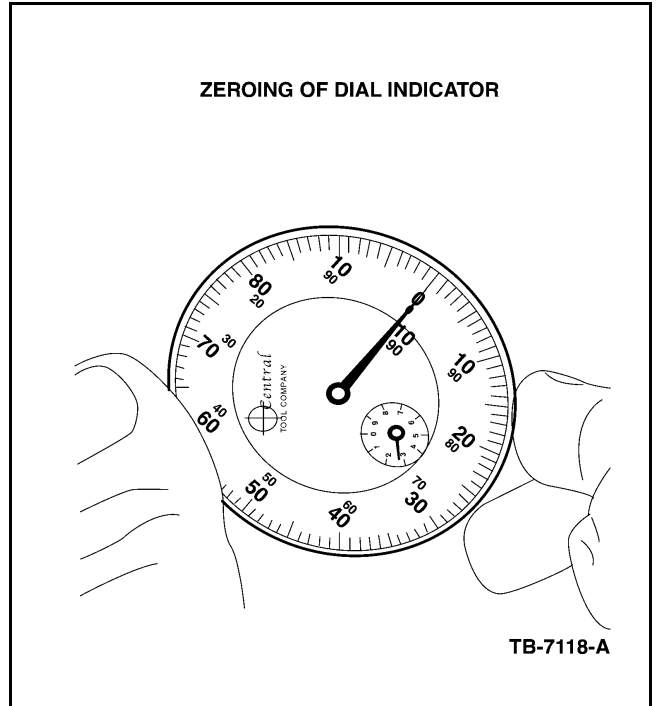
Figure 7 - Article 03-11-2

8. Apply a reasonable amount of lateral force at the 6 O'clock position (Figure 6) of the wheel and zero the indicator as shown (Figure 7).
9. Reverse the lateral force to the wheel in the opposite direction (Figure 8) and record the maximum amount of displacement measured by the indicator. Repeat several times rocking the wheel back and forth to assure a good reading.
