**ENGINE—7.3L—LOW OIL PRESSURE—CUAUTITLAN  
BUILT VEHICLES ONLY—EQUIPPED WITH 7.3L  
POWERSTROKE DIESEL ENGINE—ENGINE SERIAL  
NUMBERS (ESN) BETWEEN 5000000 AND 5008850  
ONLY**

**Article No.  
03-21-43**

**FORD:** 2001 SUPER DUTY F SERIES

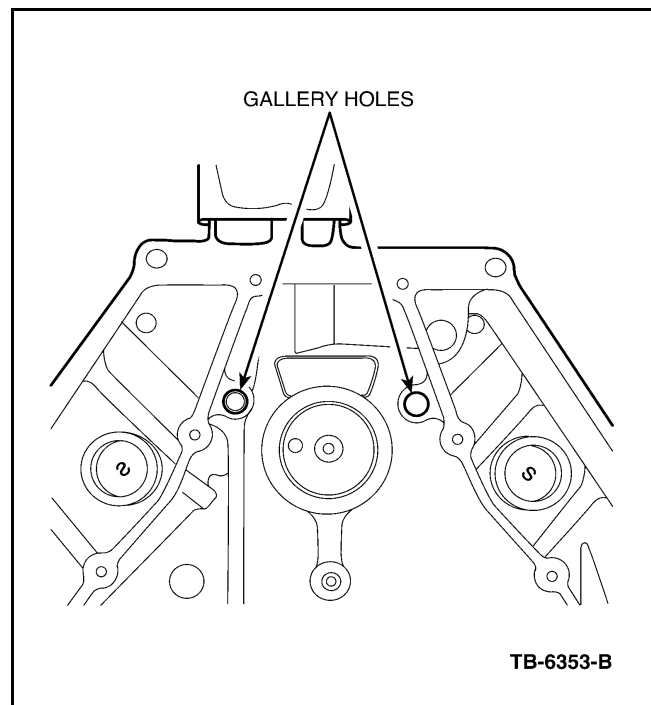
Figure 1 - Article 03-21-43

If main gallery pressure is higher than the reading at the reservoir, this indicates an internal loss of oil pressure in the short block assembly. A condition of low oil pressure may be the result from a tappet gallery plug coming out of the rear of the crankcase.

Relative to the cam, at 10 o'clock and 2 o'clock, there are two (2) holes that should have a Oil Gallery Cup Plug (40064-R1) installed. If the plug is missing, replace the cup using the following repair procedure (Figure 1).

**CARE MUST BE TAKEN PARTICULARLY ON THE 10 O'CLOCK (LEFT) HOLE NOT TO INSTALL THE PLUG TOO DEEP (THE TURBO LUBE PASSAGE COULD BE RESTRICTED), BUT THE PLUG MUST BE INSTALLED DEEP ENOUGH TO HOLD (FORD THREADLOCK 262 MAY BE USED TO ASSIST IN RETAINING THE PLUG).**

It is very important to use the approved Ford Cup Plug (40064-R1) for this repair. The use of aftermarket plugs may cause leaks due to inconsistent cup sizes.
