• **ENGINE—EXHAUST—TURBO-INDUCED EXHAUST MOAN/DRONE AT 1600-1800 RPM—6.0L BUILT PRIOR TO 9/29/2003**

**Article No.
04-9-4**

FORD: 2003-2004 EXCURSION, F SUPER DUTY

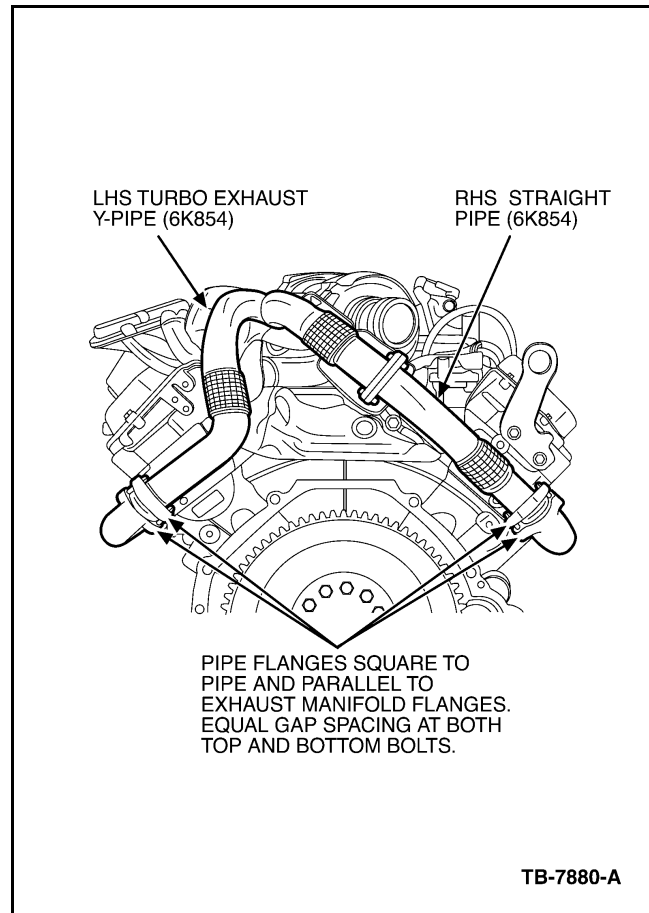
Figure 1 - Article 04-9-4

- Check for good alignment and fit of the lower LHS Y-pipe and RHS straight pipe flanges at the mating exhaust manifold outlets. Secure the LHS Y-pipe and RHS straight pipe to the exhaust manifold outlets using M8 bolts (two (2) per side). Using hand tools snug fasteners evenly to position the pipe flanges square to the pipe and parallel to the exhaust manifold flanges. There should be an equal gap spacing between the pipe flange and exhaust manifold flange at both the top and bottom bolts (Figure 1).

- Final torque LHS Y-pipe to RHS straight pipe flat flange fasteners to 27 N•m (20 lb-ft).
- Final torque LHS Y-pipe and RHS straight pipe exhaust manifold flange fasteners to 27 N•m (20 lb-ft).
- Re-secure exhaust down pipe V-band clamp and final torque to 10 N•m (89 lb-in).
- After complete reassembly, road test vehicle to confirm no exhaust leaks and exhaust moan condition is resolved.
