# WARNING INDICATORS—PARKING AID—REVERSE SENSING SYSTEM (RSS) AND FORWARD SENSING SYSTEM (FSS)—FALSE ACTIVATION OF WARNING TONE—SERVICE TIPS

TSB 04-26-2

1999-2003 WINDSTAR  
1999-2004 EXPLORER  
2000-2004 EXCURSION, EXPEDITION  
2001-2004 F-SUPER DUTY  
2003-2005 ESCAPE  
2004 F-150, FREESTAR

## ISSUE

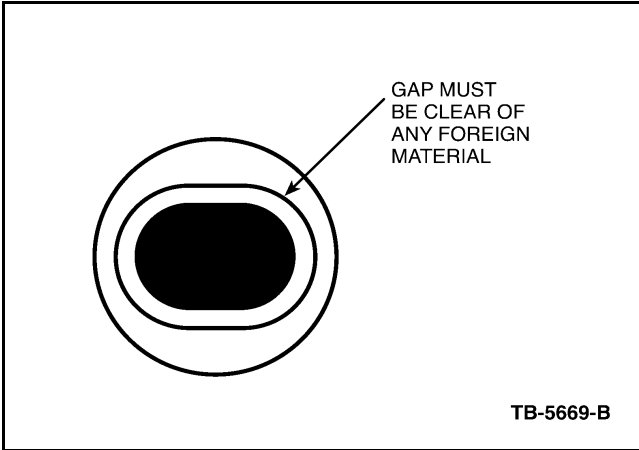
Figure 1 - Article 04-26-2

Proximity sensor surfaces may be covered with snow, ice, dirt or mud. There is a gap between the sensor membrane and its plastic housing that must remain clear (Figure 1). If this space is contaminated with any foreign material the system may sound a continuous tone or intermittent tone. The sensor surface can be cleaned by a high pressure water spray.

2. Clean proximity sensors with a dry shop towel, and if required wash with water or a high pressure water wash if necessary to ensure that the membrane gap is free of any dirt or contamination.
