**TRANSMISSION—E4OD—HEAT STAINED OVERDRIVE PLANETARY GEARSET, COAST CLUTCH CYLINDER BUSHING AND/OR OVERDRIVE CYLINDER BUSHING**

**Article No.  
95-21-9**

**FORD:** 1995 BRONCO, ECONOLINE, F SUPER DUTY, F-150-350 SERIES

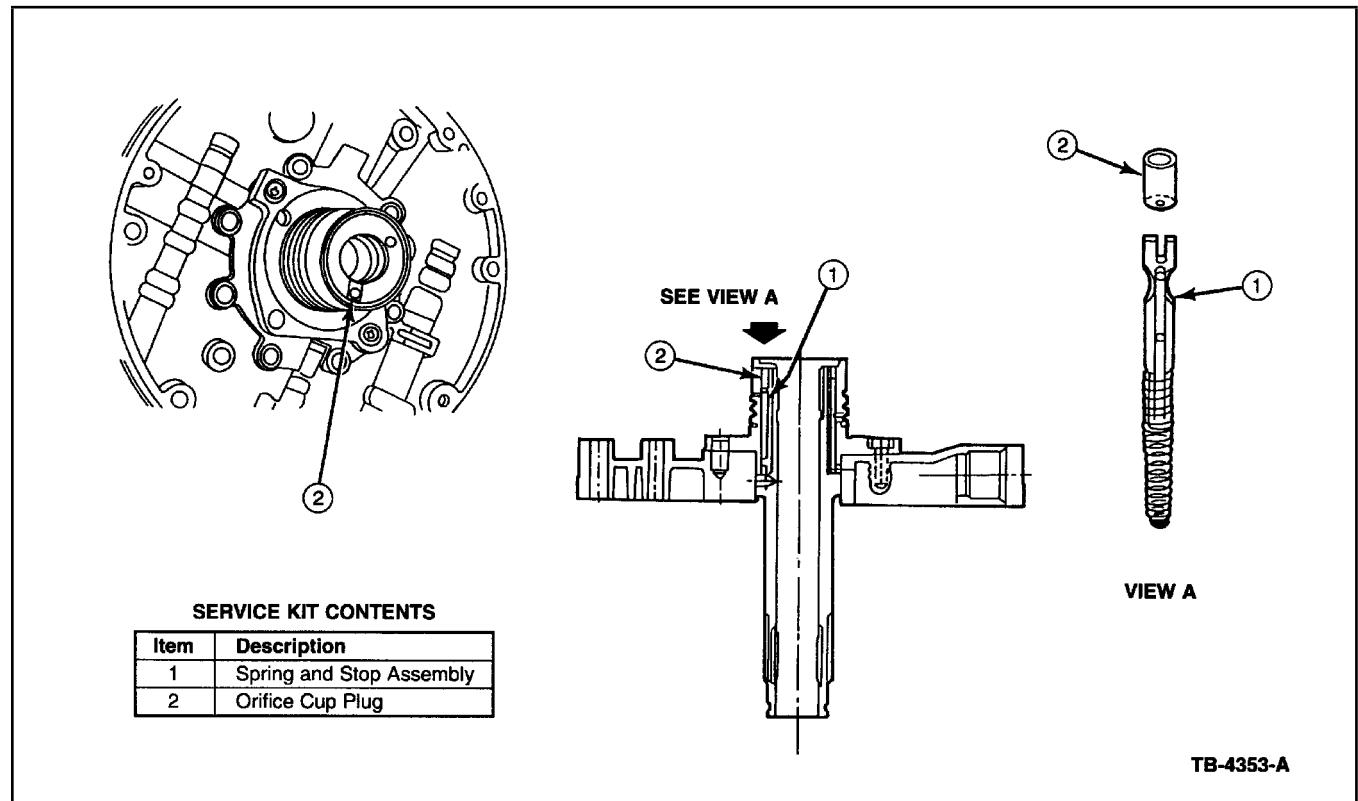
Figure 1 - Article 95-21-9

Some E4OD transmissions with build dates between 5B03 (February 3, 1995) and 5E31 (May 31, 1995) may have a valve, in the pump, that restricts fluid flow (Figure 1). This valve may become stuck in the valve bore and restrict lubrication. Symptoms may include heat distress on the overdrive planetary gearset, coast clutch cylinder bushing and/or overdrive cylinder bushing.

During overhaul of E4OD transmissions with build dates 5B03 and 5E31, inspect the components listed above for signs of heat distress. Replace the valve assembly using a service valve kit

(E9TZ-7H132-B) which should resolve the issue. Refer to the Instruction Sheet included in the kit for details.
