- **ELECTRICAL—VEHICLE SPEED SIGNAL (VSS) INPUT NOTICED WHEN TESTING WITH NEW GENERATION STAR TESTER (NGS) WHEN VEHICLE IS STOPPED—SUPER DUTY F-53 MOTORHOME CHASSIS VEHICLES BUILT 1/2/1998 THROUGH 7/31/2000**
- **TRANSMISSION—4R100—TRANSMISSION STARTS OUT IN 2ND GEAR—ERRATIC 1-2 UPSHIFT OR ERRATIC 2-1 DOWNSHIFT FROM TRANSMISSION—SUPER DUTY F-53 MOTORHOME CHASSIS VEHICLES BUILT 1/2/1998 THROUGH 7/31/2000**

**Article No.
02-11-3**

FORD: 1999-2000 SUPER DUTY F-53 STRIPPED CHAS.

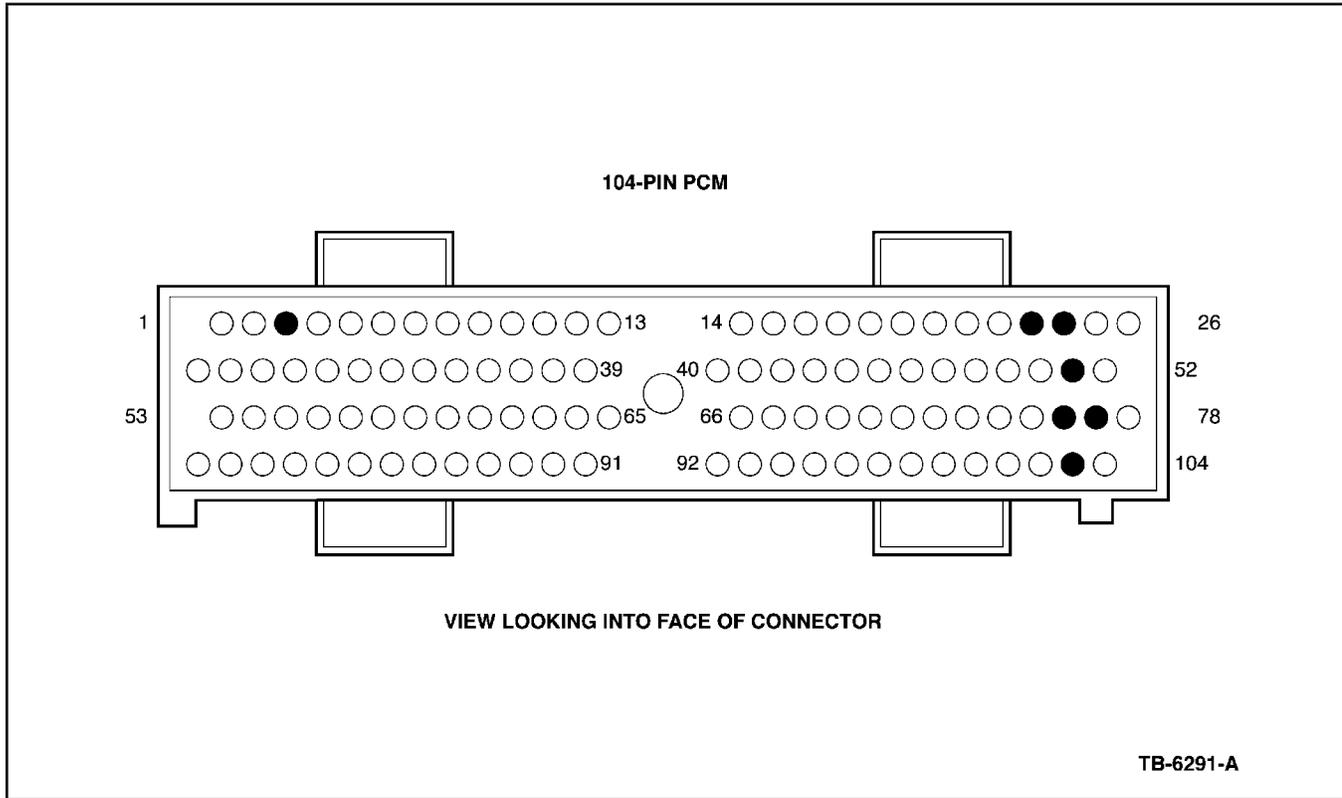
Figure 1 - Article 02-11-3

Some vehicles may exhibit an erratic transmission 1-2 upshift or 2-1 downshift or may start out in 2nd gear. This may be caused by a vehicle speed signal from the Anti-lock Brake System (ABS) module that is contaminated with engine electrical noise from the engine wiring harness on the ground circuit. A vehicle speed input to the Powertrain Control Module (PCM) may be noticed when using a New Generation Star (NGS) tester to monitor the Vehicle Speed Sensor (VSS), even when the vehicle is not moving.

4. Bolt the original ground eyelets to the sheet metal using this new hole (Bolt: N805503-S301 and Nut: N620480-S301).
5. Remove the PCM connector.
6. Remove the black plastic shield from the back of the PCM connector.
7. Remove the red locking plate from the front of the connector.
8. Using the sharpened paper clip tool (or small screwdriver), open the locking tabs and remove the pins as shown (Figure 1).

TO INSURE THE CORRECT PINS WERE REMOVED, THE RESISTANCE SHOULD BE "0" OHMS BETWEEN ALL SEVEN (7) PINS.
