- **DRIVEABILITY—LOSS OF POWER AND EXTERNAL TURBO OIL LEAK—7.3L DIESEL**
- **ENGINE—7.3L DIESEL—LOSS OF POWER AND EXTERNAL TURBO OIL LEAK**
- **NOISE—EXHAUST NOISE FROM TURBO—7.3L DIESEL**

**Article No.  
03-21-49**

**FORD:** 1999-2001 E SERIES, SUPER DUTY F SERIES  
2000-2001 EXCURSION, F-650, F-750

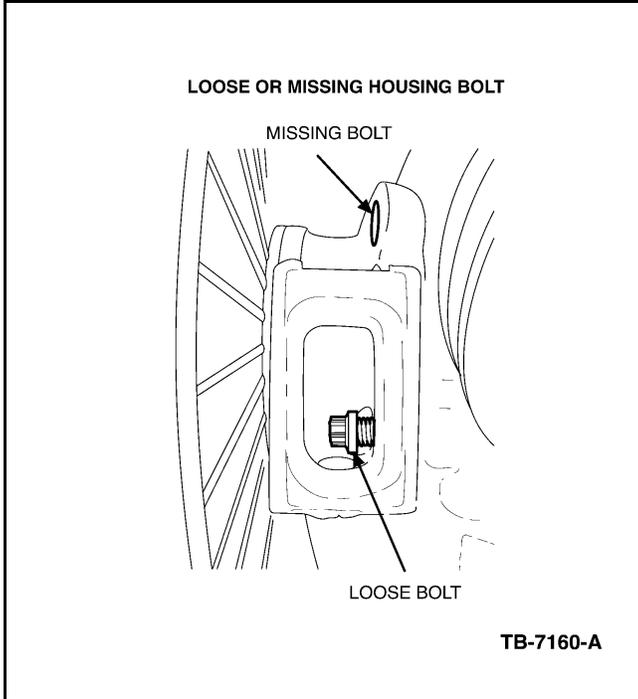
Figure 1 - Article 03-21-49

Visually inspect the turbo housing for loose or missing turbo housing bolts (Figures 1 and 2). If turbo housing bolts are loose or missing, use Turbo Housing Bolt Kit 1C3Z-9G486-AA to replace the bolts. The new bolts are torque prevailing bolts (Figure 3).
