WATER LEAK—ROOF FLANGE AREA—WATER ACCUMULATION IN HEADLINER AND/OR LEAK AT THE CAB FLOOR PAN AREA

TSB 04-23-9

1999-2005 F-Super Duty
2004-2005 F-650, F-750

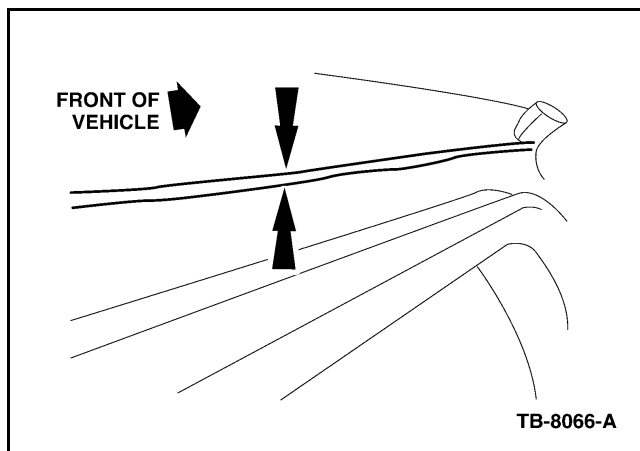
Figure 2 - Article 04-23-9

Some 2004-2005 F-650/750 and 1999-2005 F-Super Duty vehicles may exhibit water entry into the cab through the roof to roof flange seam, at the A-pillars. Customer may describe as water accumulating in the headliner, floor pan or bulkhead area.

3. Inspect for gaps between the roof flange and roof rail flange (Figure 2).

4. Clear debris and dry flanges with compressed air (oil free).
5. In all visible gaps, apply Motorcraft Clear Silicone Rubber, TA-32, or equivalent meeting Ford Specification ESB-M4G92-A.
6. Allow Silicone Rubber to dry per manufacture's instructions.
7. Reinstall drip rail weather strip.
8. Repeat procedure on passenger side of vehicle.
