Pump Operation

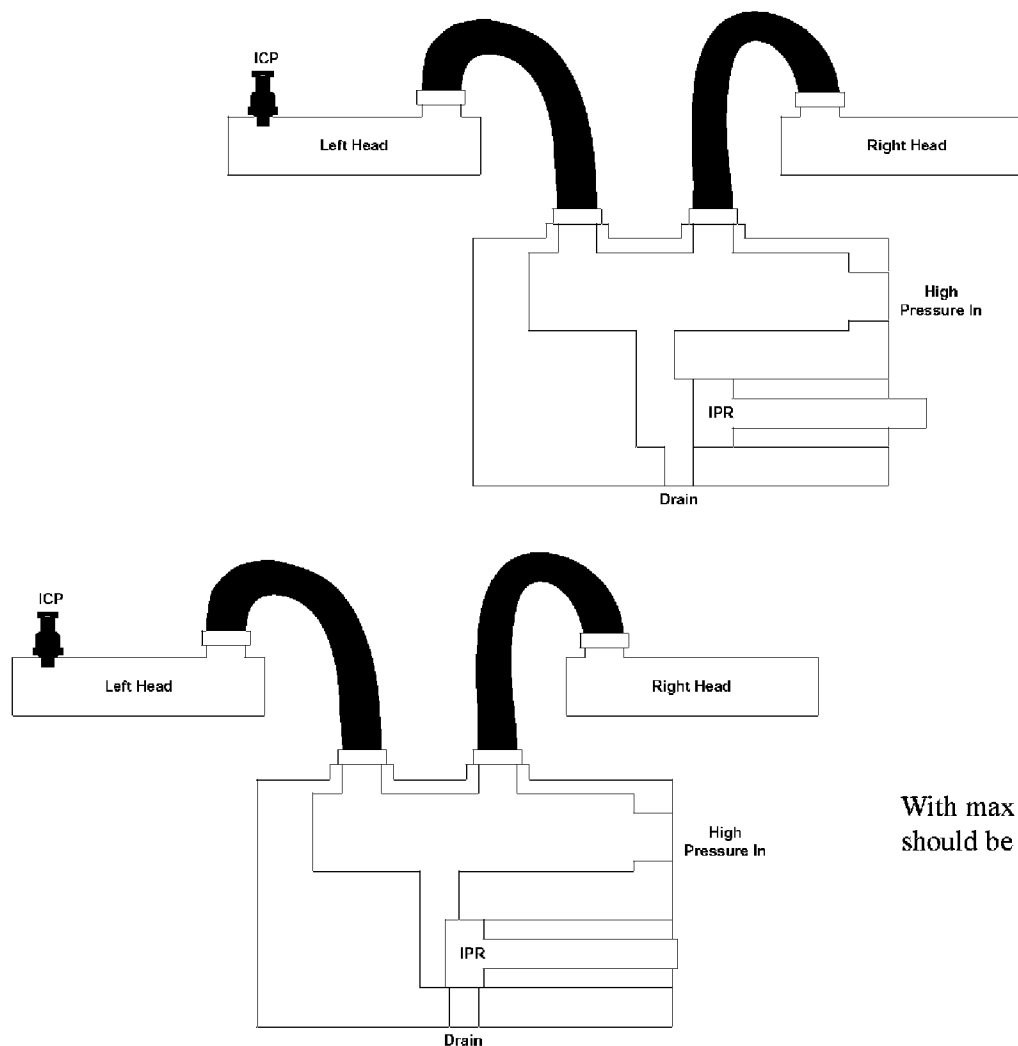
The IPR acts to increase ICP by restricting the path to drain.
