• **SUSPENSION—ON-VEHICLE FRONT INTEGRATED HUB/BEARING ROCKING END-PLAY MEASUREMENT**

**Article No.
03-11-2**

FORD: 1999-2004 SUPER DUTY F SERIES
2000-2004 EXCURSION

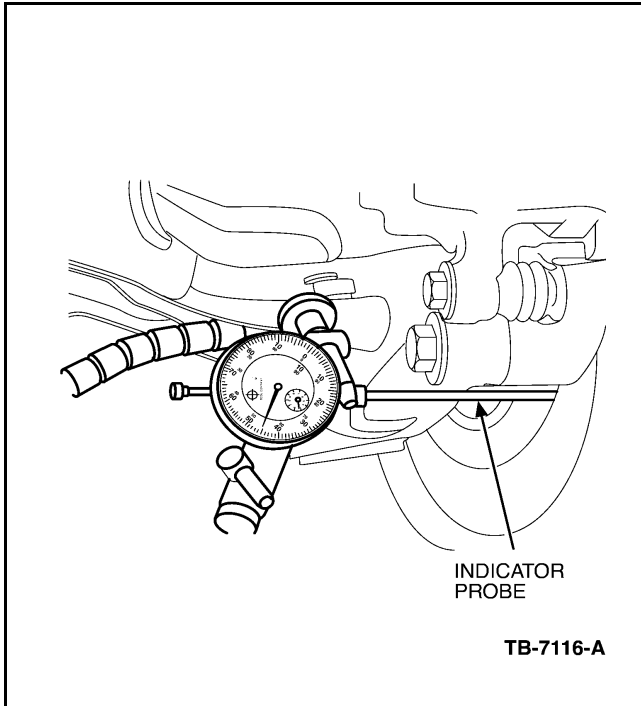
Figure 4 - Article 03-11-2

6. Fasten the dial indicator base (Figure 2), from Rotunda Kit 164-R2724 (or equivalent), to the knuckle as shown (Figure 3).
7. While adjusting goose neck, place probe of indicator on Rotor where splash shield has a V-type opening on inboard side of suspension assembly or about at the 5 O'clock position (Figure 4). Set the probe so that it is free to move in the lateral direction (Figure 5). With indicator and probe set in their mid-point range of operation, tighten the goose neck until it is rigid enough to assure accurate readings.
