TRANSMISSION—ALL—VEHICLE CAN BE SHIFTED OUT OF “PARK” WITHOUT DEPRESSING BRAKE PEDAL—ECONOLINE CUTAWAYS ONLY AND F-SERIES BUILT THROUGH 2/28/95

**Article No.
96-8-18**

FORD: 1994-1995 BRONCO, ECONOLINE, F SUPER DUTY, F-150-350 SERIES

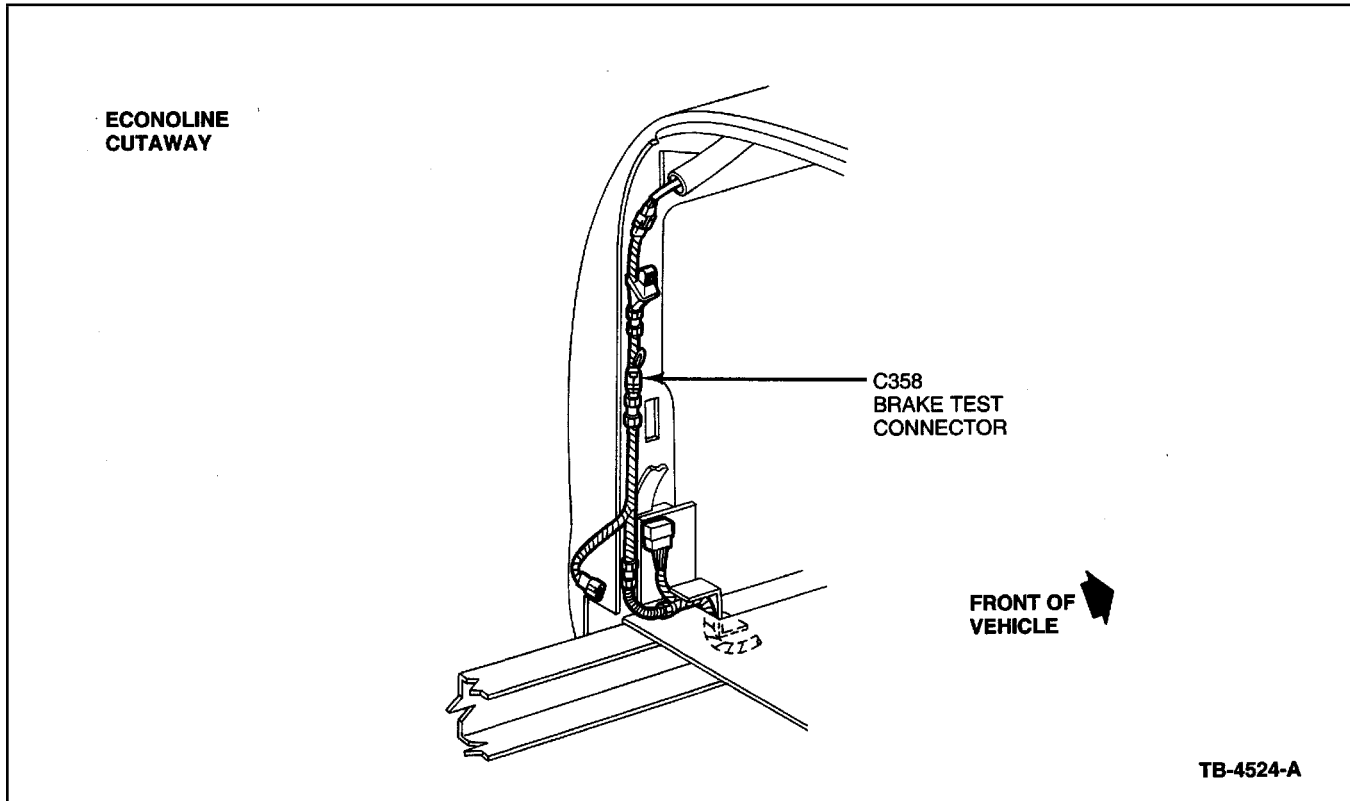
Figure 1 - Article 96-8-18

1. If a high mount stoplamp is installed, check to make sure the bulb filament is not missing or open. Repair as required.
2. Locate the -14A200- wire harness along the B-pillar behind the driver's seat.
3. Locate brake test connector C358, Figure 1. This is a 2-way gray connector.
4. Install the jumper into the connector.
5. Wrap the main body wire harness with polyken tape. This will hold the connector in place and prevent any rattles of the connector to the B-pillar.

Install a jumper harness with a resistor to simulate the presence of a high mount stoplamp or replace the high mount stoplamp if the bulb is open. Refer to the following Service Procedure for details.
